ALERT: Alarm Not Activated after Infusion Pump Tubing Incorrectly Loaded

ISMP Canada Safety Bulletin

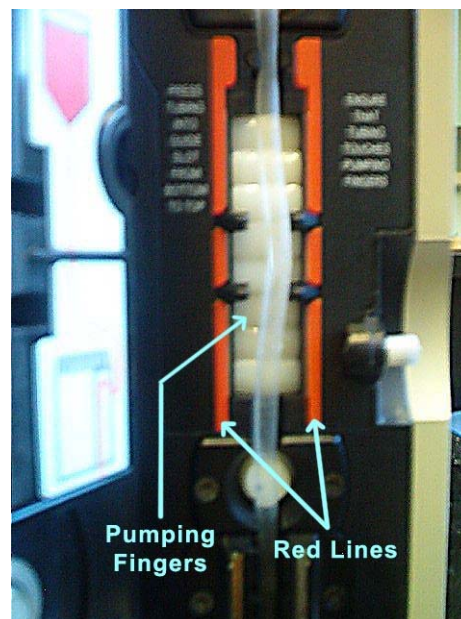
Figure 1. Over-infusion replicated.

The causes of these separate mishaps were not determined until the biomedical, management and front-line staff of one of the reporting hospitals conducted in-depth investigations. It was discovered that tubing loaded in a “curved” manner caused over-infusion and did not activate an alarm (see Figure 1). They also reported that both no flow and under-infusion could occur without an alarm if the loaded tubing became kinked or pinched (see Figure 2). ISMP Canada has since replicated all these “no alarm” scenarios with the 6201 model of the Baxter Flo Gard pump. (Model 6201 is the single channel and model 6301 is the dual channel version of the Flo Gard pump. These two models have identical pumping mechanisms.)

Tubing incorrectly loaded in curved manner between red lines did not activate pump alarm.

order for an infusion pump to deliver the amount of solution programmed, not only must the pump be in proper working order, but the tubing must also be loaded correctly. In the over-infusion scenario, the curved tubing created periods during which the pumping mechanism was not in direct contact with the tubing. It was only during these periods that fast rates could be visualized in the drip chamber. Despite the over-infusion, the pump continued to display the amount infused corresponding to the set infusion rate because it did not recognize any problems with the position of the tubing. Thus, it is imperative that the user follow the manufacturer's instructions to ensure that the tubing is loaded straight and lying against the pumping fingers to facilitate accuracy in the delivery of intravenous solutions.

A curve in the tubing can readily result if the user allows slack in the tubing when loading it into the pump. Once the pump door is closed, any slack in the tubing can cause the tubing to become curved, kinked or pinched. The user manual provided by the manufacturer indicates that an alarm with a "check set loading" message and no flow of infusion occurs if the tubing is not loaded correctly. Users rely on pumps to identify problem conditions and to activate an alarm. During replication of the reported incidents it was found that tubing incorrectly loaded in a variety of ways on or between the red lines (see Figures 1 and 2) did not activate an alarm and subsequently led to over-infusion or under-infusion. Ideally, infusion pump sensors will activate an alarm for all cases of incorrectly loaded tubing in order to prevent over-infusion or under-infusion. Furthermore, correct loading of tubing into a pump should be a forced function, not relying on the user's technique.

ISMP Canada recommends that those hospitals using Baxter Flo Gard models 6201 and 6301 consider implementing the following safeguards:

- Educate all healthcare staff using these pumps that there may be a "no alarm" condition with improperly loaded tubing.
- Retrain all healthcare staff on the proper loading of the tubing according to instructions provided in the pump user manual, as well as the manufacturer's updates and labels. Emphasize the risks associated with incorrectly loaded tubing.

- Address this issue in all pump training sessions provided to new staff during orientation (including anaesthesiologists).
- Place brightly coloured, laminated labels on the pumps, with the warning of the possibility of no alarm with incorrectly loaded tubing.

- If using this pump for the delivery of high alert medications, consider additional safeguards that would be feasible for your organization after performing a Failure Mode and Effect Analysis (FMEA). Safeguards may include an independent double check on loading of tubing, the use of a buretrol with these pumps (with a specified volume limit, related to the drip rate in the volume control chamber) or another method that would create redundancy. A list of high alert medications can be found on the ISMP website:
www.ismp.org/msaarticles/highalertmedications.htm.

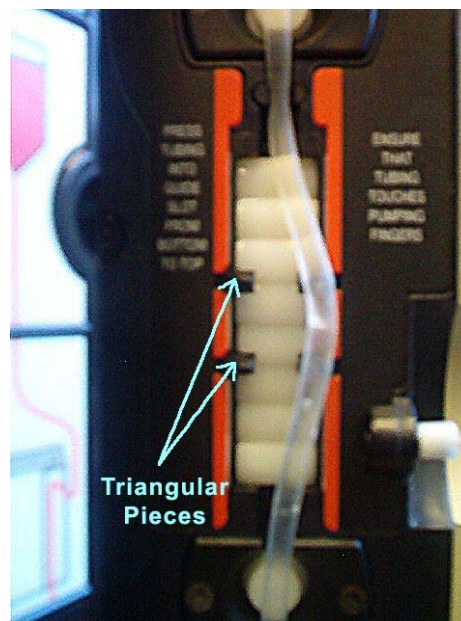
Figure 2. No flow replicated.

Tubing pinched against triangular pieces when door was closed did not activate alarm.
