Latent Failures Identified with CADD[®] Pump Error Analysis

ISMP Canada provided assistance with a medication error analysis of an accidental overdose with hydromorphone administered subcutaneously by a CADD-Legacy[®] PCA Model 6300 pump. The analysis focused on identifying relevant underlying contributing factors (latent failures) for the purpose of developing recommended actions to prevent recurrence. Findings are shared in this bulletin with permission from the hospital.

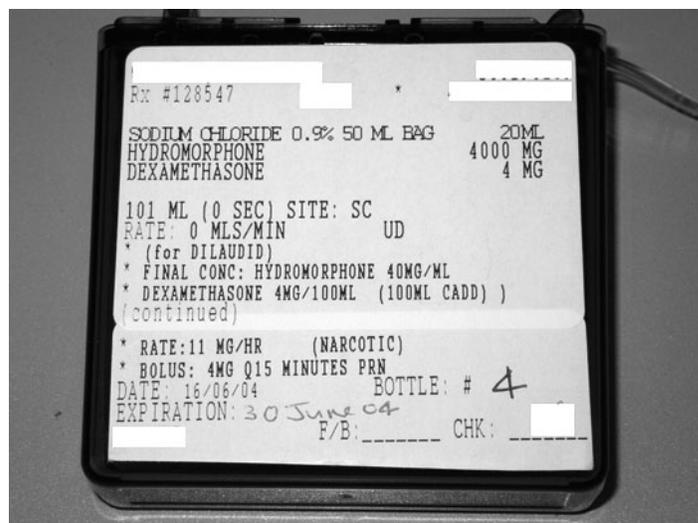
Figure 1: CADD[®] pump cassette label

Note: Although not directly contributing to the incident, it was found that the cassette label was not visible unless the cassette was removed entirely from the pump case and turned

over. It was also found that critical information was not prominent and was difficult to comprehend on the pharmacy-generated cassette label. See Figure 1.

- Provide a mechanism and a procedure for nursing staff to resolve conflicting order information.
- Review pharmacy labels so that they are designed with the end-user in mind and to prominently display critical information. Work with pharmacy computer system vendors, and ensure input from nursing representatives, to optimize label information display.
- Implement pharmacy processes for standardization of label placement on cassettes to ensure optimal visibility.
- Standardize the concentrations of formulary opioid solutions. For added safety use the lowest concentration possible.
