Volume 8, Number 4

# ISMP Canada Safety Bulletin

June 30, 2008

## Prefilled Syringes of Epinephrine and Compatibility with Intravenous Tubing

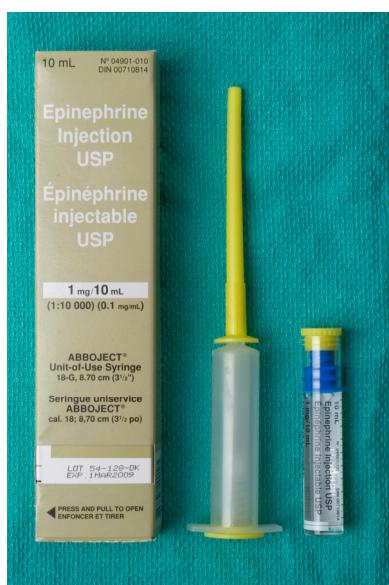
A male cardiac patient in his early 50s, who was undergoing electrocardiographic monitoring, experienced a cardiac arrest. Resuscitation measures were initiated immediately, however the cardiac arrest cart was found to contain only prefilled syringes of epinephrine 1 mg/10 mL intended for intracardiac administration (Figure 1), rather than the LifeShield prefilled syringes of epinephrine 1 mg/10 mL (Figure 2) that were to have been stocked on the cart. In contrast to the LifeShield syringes, which are compatible with needleless intravenous (IV) tubing, intracardiac prefilled syringes are incompatible with needleless IV tubing, and therefore the epinephrine could not be administered. The physician in charge of the cardiac arrest team administered an alternative medication, the

**Figure 1:** Prefilled syringe of epinephrine 1 mg/10 mL for intracardiac administration has a nonremovable 8.7 cm (3.5 inch) needle attached. From left to right: outer package, syringe, and cartridge.

- Review the need for intracardiac prefilled syringes of epinephrine.
  - The facility is reviewing its need for prefilled syringes of epinephrine intended for intracardiac administration.

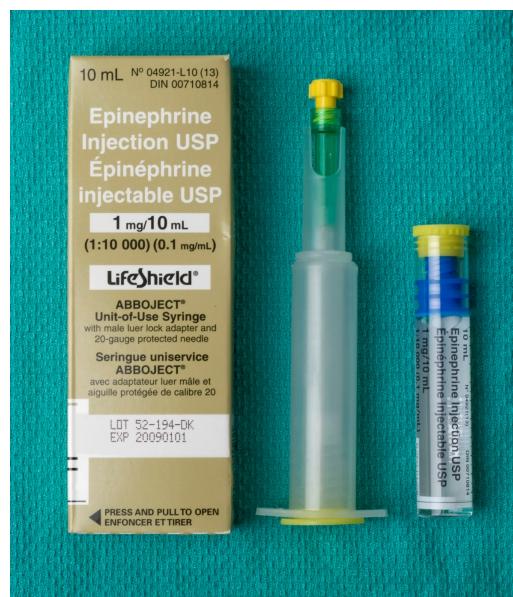
**Figure 2:** LifeShield prefilled syringe of epinephrine 1 mg/10 mL, has a "shield" surrounding the nonremovable 3.81 cm (1 inch) needle. The product has a luer-lock tip, which makes it compatible with needleless IV tubing. From left to right: outer package, syringe, and cartridge.

situation, the manufacturer typically offers an alternative product; for example, if the LifeShield product (Figure 2) is on back-order, hospitals with needless systems may temporarily receive the epinephrine syringes with the attached needle (Figure 3). When this happens, facilities need to have a strategy to ensure that the appropriate adapters are available to allow compatibility with their standard IV tubing, and ensure that staff are aware of availability and are familiar with the use of the adapters.

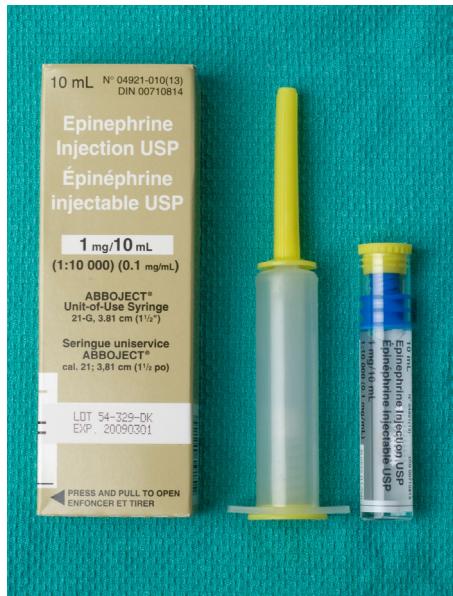
All cardiac arrest carts in the facility were checked during follow-up to this incident. Although no other intracardiac syringes were found, *a number of the carts were found to be unintentionally stocked with an incorrect epinephrine product, specifically prefilled syringes with a needle* (Figure 3), rather than the intended LifeShield prefilled syringes (Figure 2). Staff members at the facility believe that this incidental finding was crucial in helping to avert similar critical incidents.

**Figure 3:** Prefilled syringe of epinephrine 1 mg/10 mL, has a nonremovable 3.81 cm (1.5 inch) needle. This syringe is not compatible with needless IV tubing. From left to right: outer package, syringe, and cartridge.

- Ensure that adapters are available on carts so that needless tubing can accept a needle, and provide education about the use of such adapters to pharmacy, nursing, and physician staff. Although training in the use of needless systems and adapters is common when needless systems are implemented, it may be less common after these systems are in place for many years.

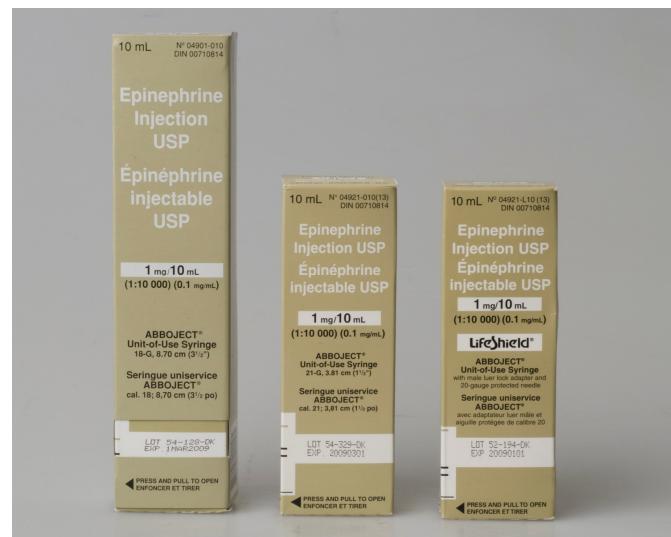
- Prefilled syringes of epinephrine incompatible with needless IV tubing were inadvertently ordered from the manufacturer and placed in pharmacy stock.
- The similarity in packaging for the different epinephrine products (Figure 4) increased the likelihood that staff members (including pharmacy staff, and the nurses in various patient care areas who routinely checked the cardiac arrest carts) would not identify the error.
- The brand name “LifeShield” appears on the outer package of this type of prefilled syringe (Figure 2), but it is possible that the presence or absence of this name would be noted only in a side-by-side comparison (Figure 4).

**Figure 4:** The outer packaging for the 3 types of prefilled syringes of epinephrine 1 mg/10 mL discussed in this safety bulletin.

- Check supplies of epinephrine products to ensure that the correct (i.e., intended) prefilled syringe product(s) are stocked.
- Check to ensure that pharmacy storage labels clearly indicate the type of prefilled product stored (e.g., epinephrine 1 mg/10 mL prefilled - LifeShield).
- Review the pharmacy purchasing and inventory systems to minimize the risk of inadvertently ordering incorrect epinephrine products.

In follow up to this incident, ISMP Canada has contacted Hospira, the manufacturer of the epinephrine products described in this article. The company is in the process of reviewing product labelling for its complete portfolio and will specifically enhance the distinctions among various epinephrine products available in prefilled syringes.
